Technical Inspection Report  
Bureau of Ordnance Group

OPERATION CROSSROADS.

TESTS 'A' AND 'B'.  
VOLUME III.  
PART I.  
Photographic  
Appendix [u]. 8

Subject: Bureau of Ordnance Material Group Final Report for Tests "A" & "B".

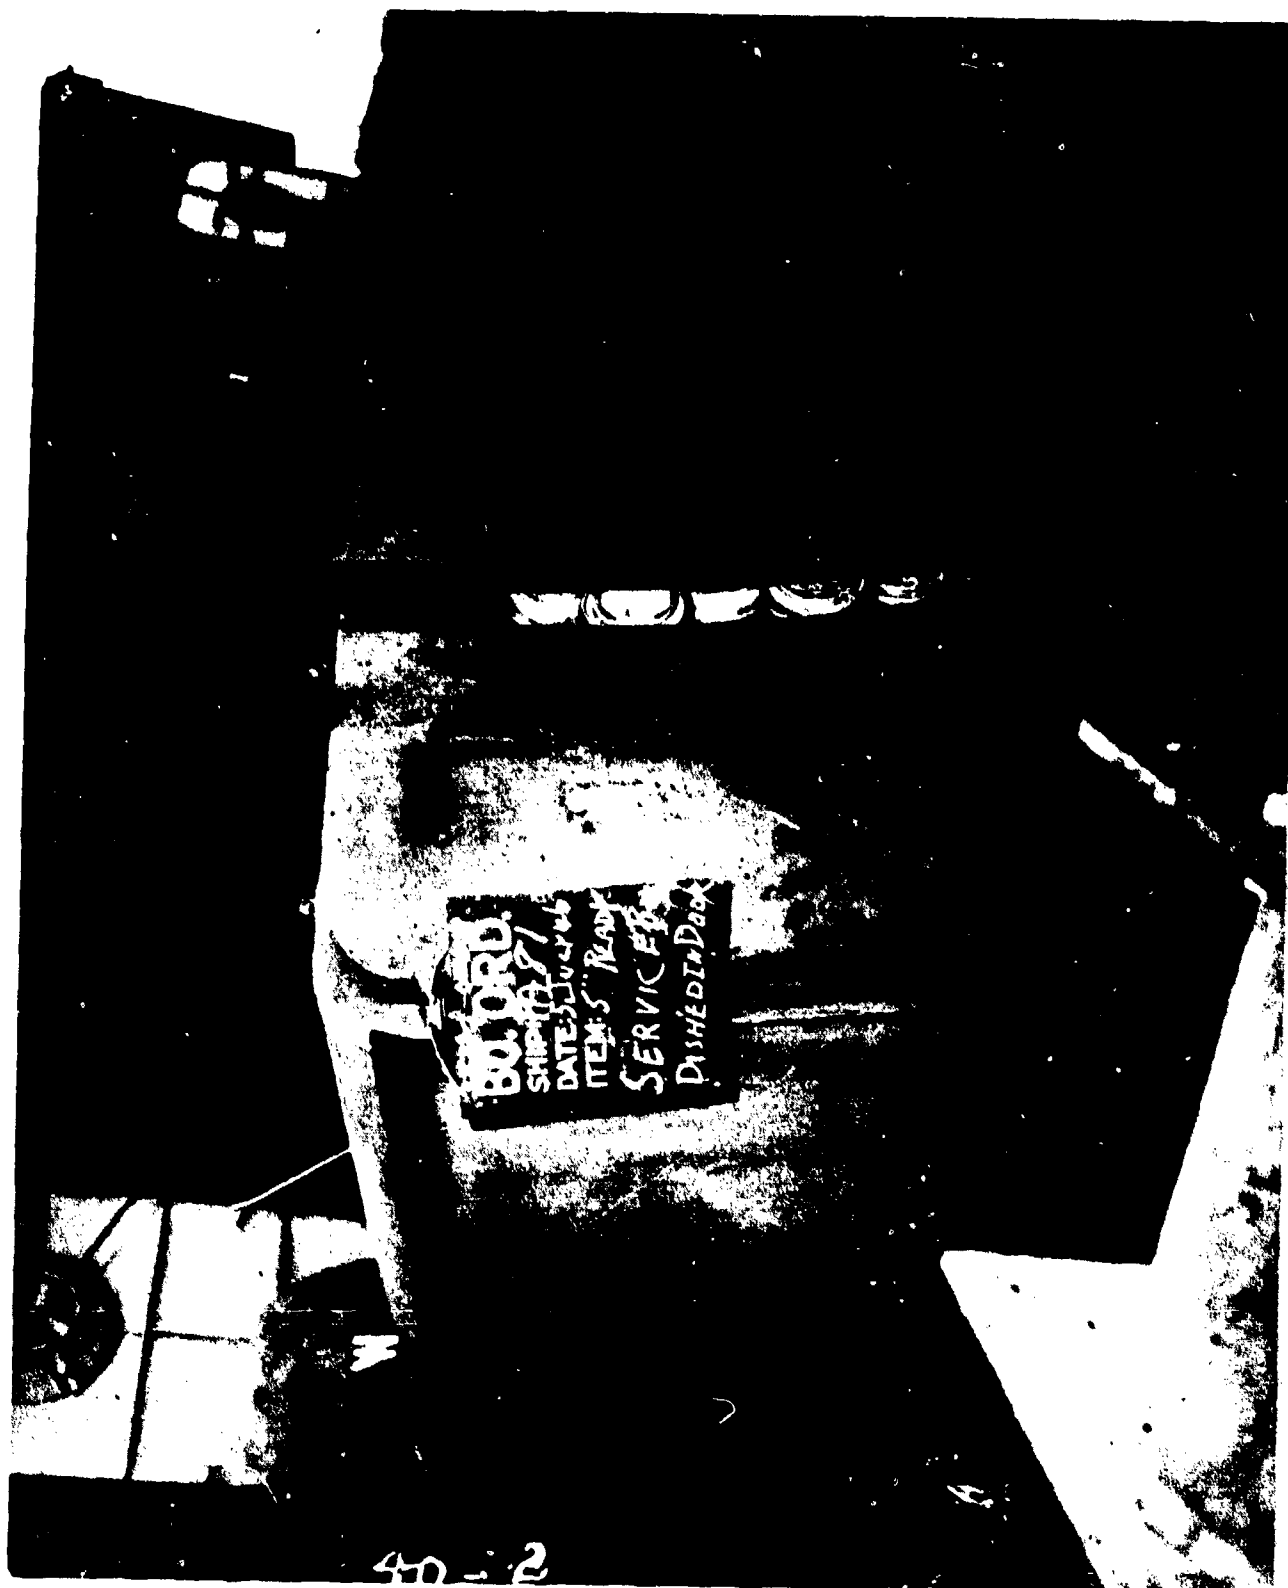
U.S.S. FALLON (APA-81) - After Able  
Shows the blast damage incurred to the 5"/38 Ready Service Locker and 5"/38 Powder  
Tanks. The Powder Tanks in position parallel to the edge of the doors were indented  
however, withdrawal of the Cartridge Cases revealed no damage. Surveillance Test  
of the smokeless powder exhibited no signs of damage or deterioration.  
Photo. No. AA-CR-87-2540-2.

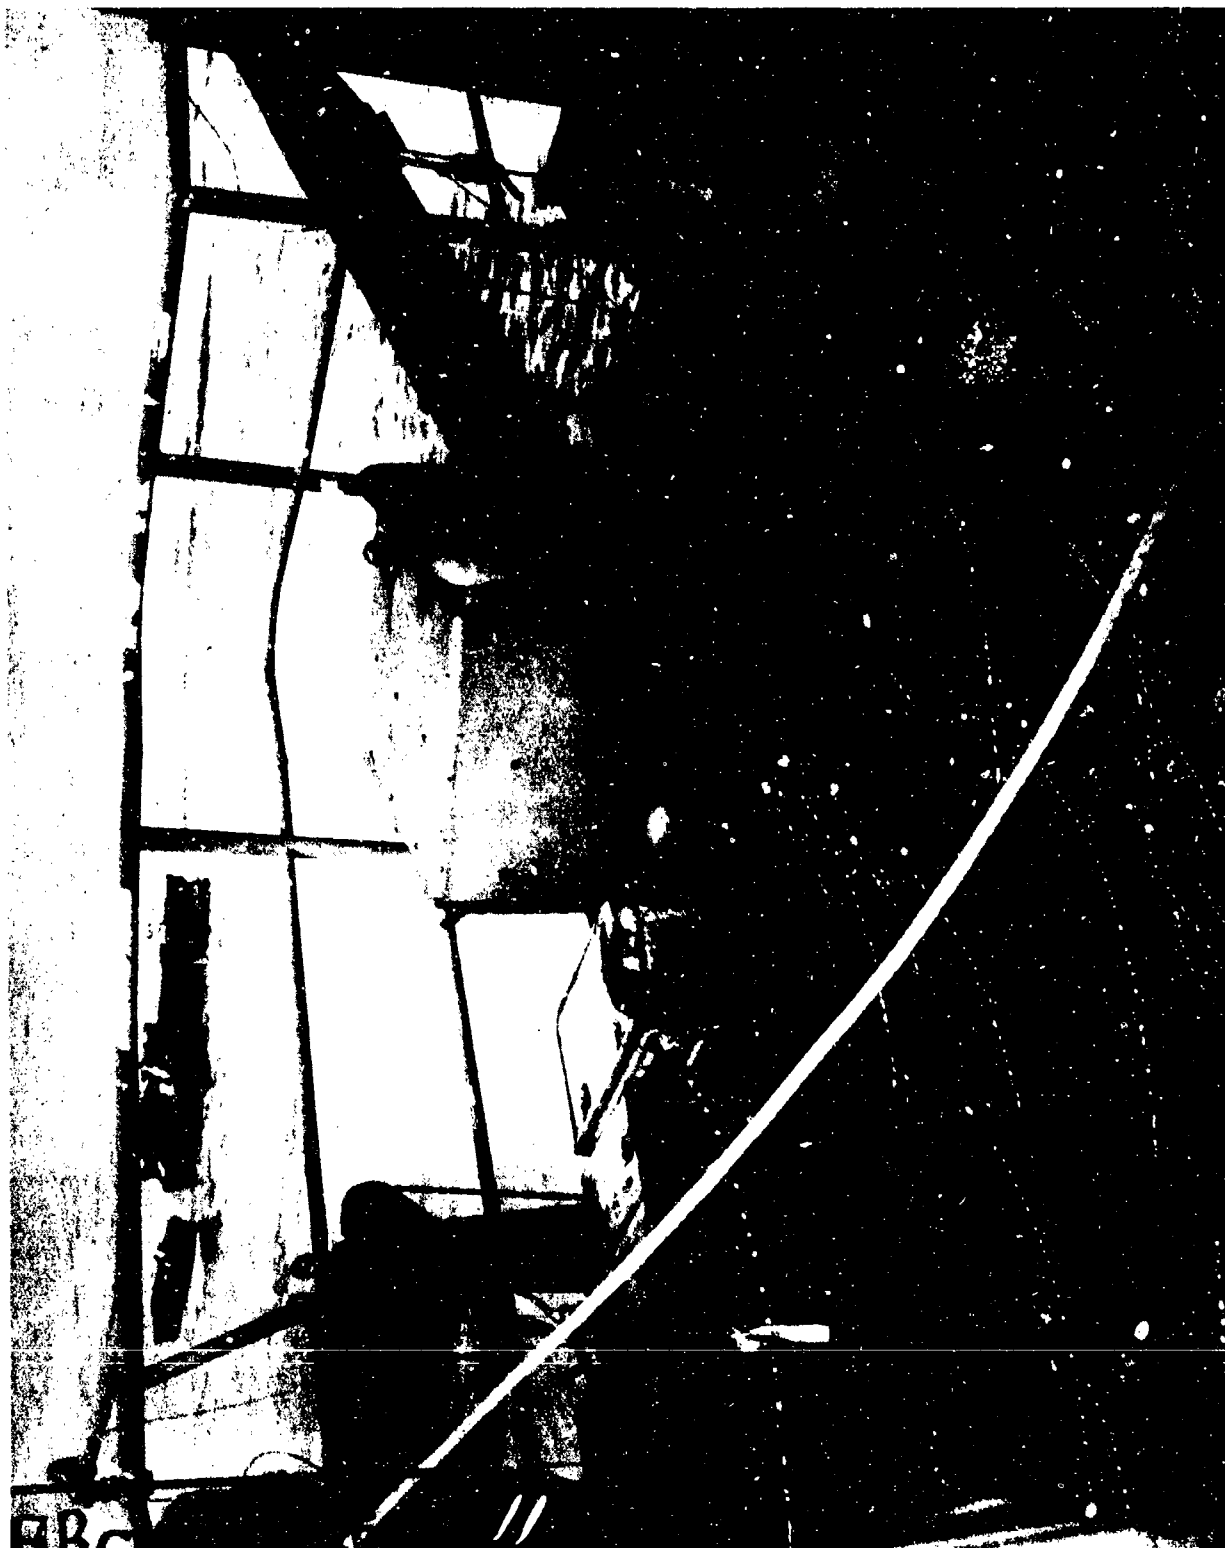
U.S.S. FALLON (APA-81) - After Baker

Shows the effect of shock on the 20 MM Ammunition Ready Service Box. The sudden upward movement of the ship was of such magnitude that the deck fittings of the Ready Service Box failed to remain fast. The Ready Service Box was filled to its capacity with boxed 20 MM Ammunition; this is promulgated to furnish an estimated gross weight. Dented case of ammunition that was spilled from the Ready Service Box may be seen in the foreground. Photo. No. AB-CR-62-4166-11.

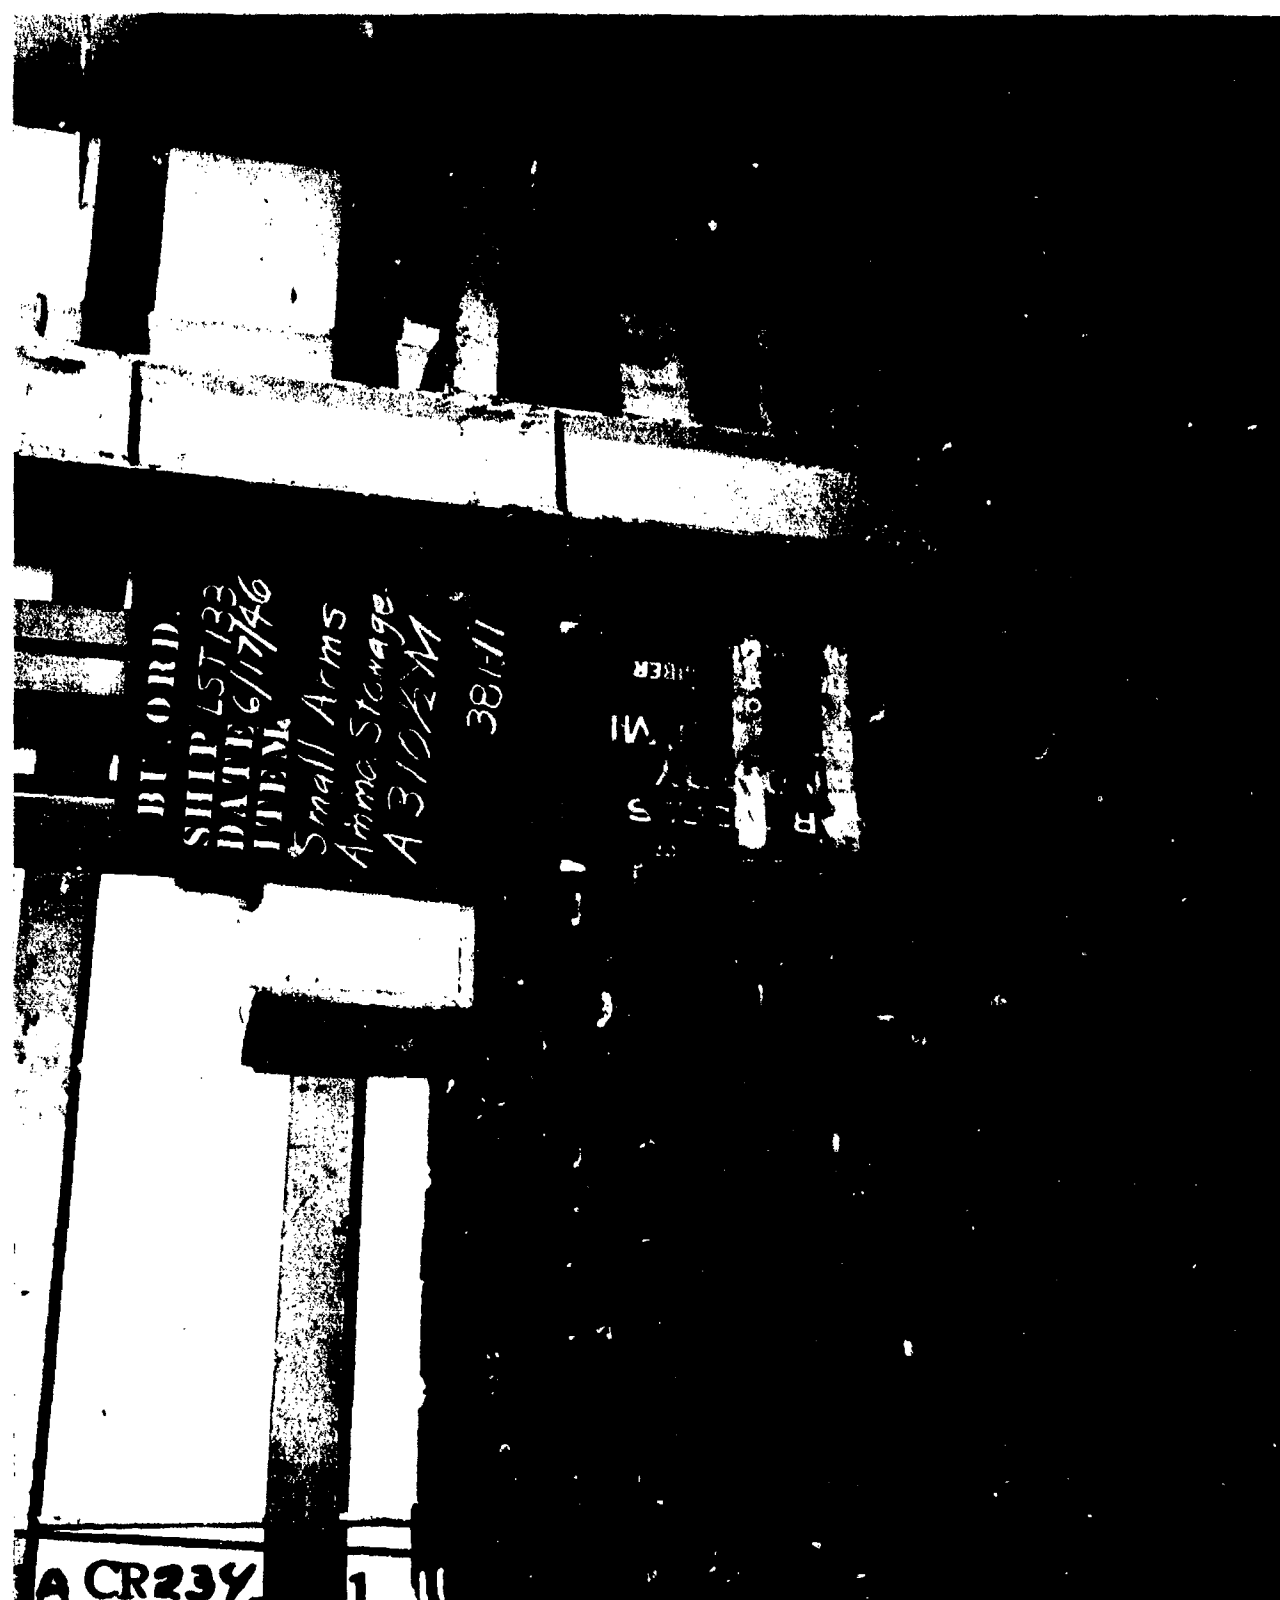
U.S.S. LST-133 - Before Able  
Shows the Small Arms Stowage in Magazine, A-3101-M,  
prior to Test "A".  
Photo. No. BA-CR-234-381-11.

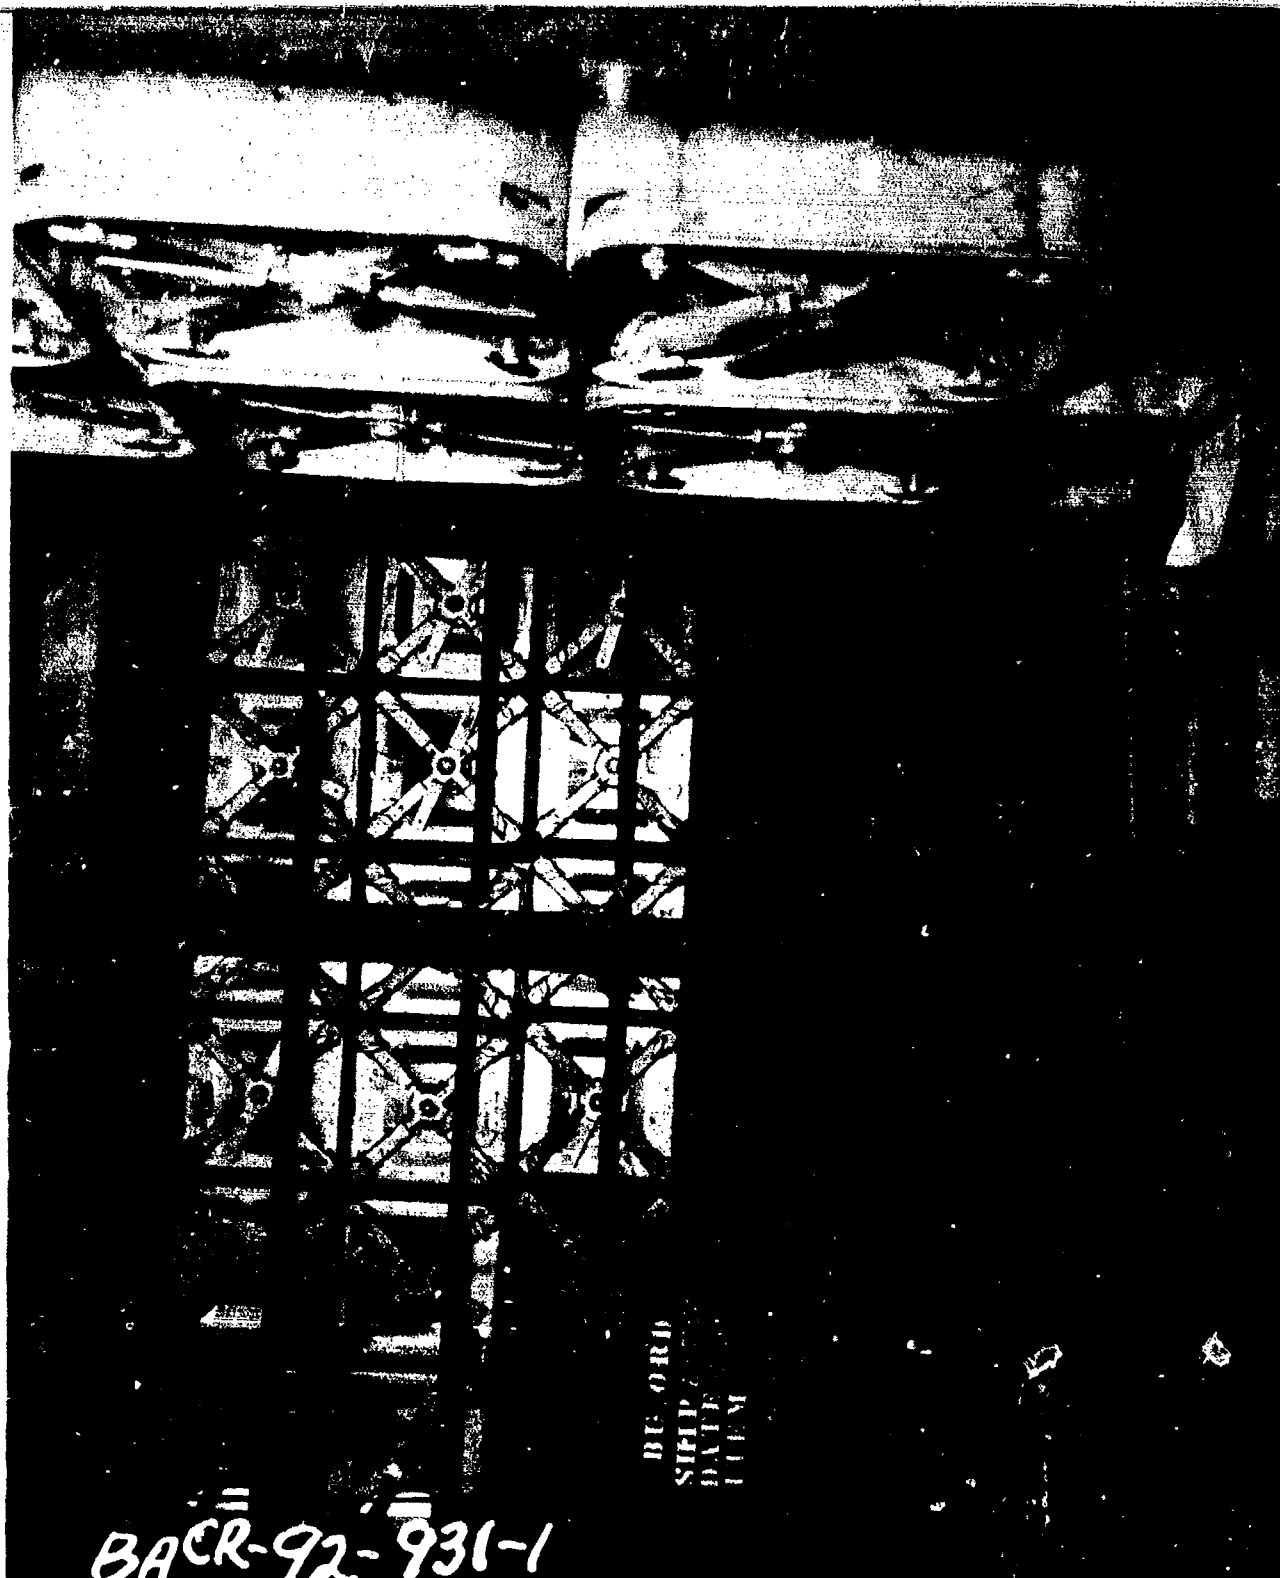
U.S.S. LST-545 - Before Able  
Shows the 40 MM Ammunition Stowage prior to Test "A".  
The Stowage as shown in this view is typical for LST's.  
Photo. No. BA-OR-92-931-1.

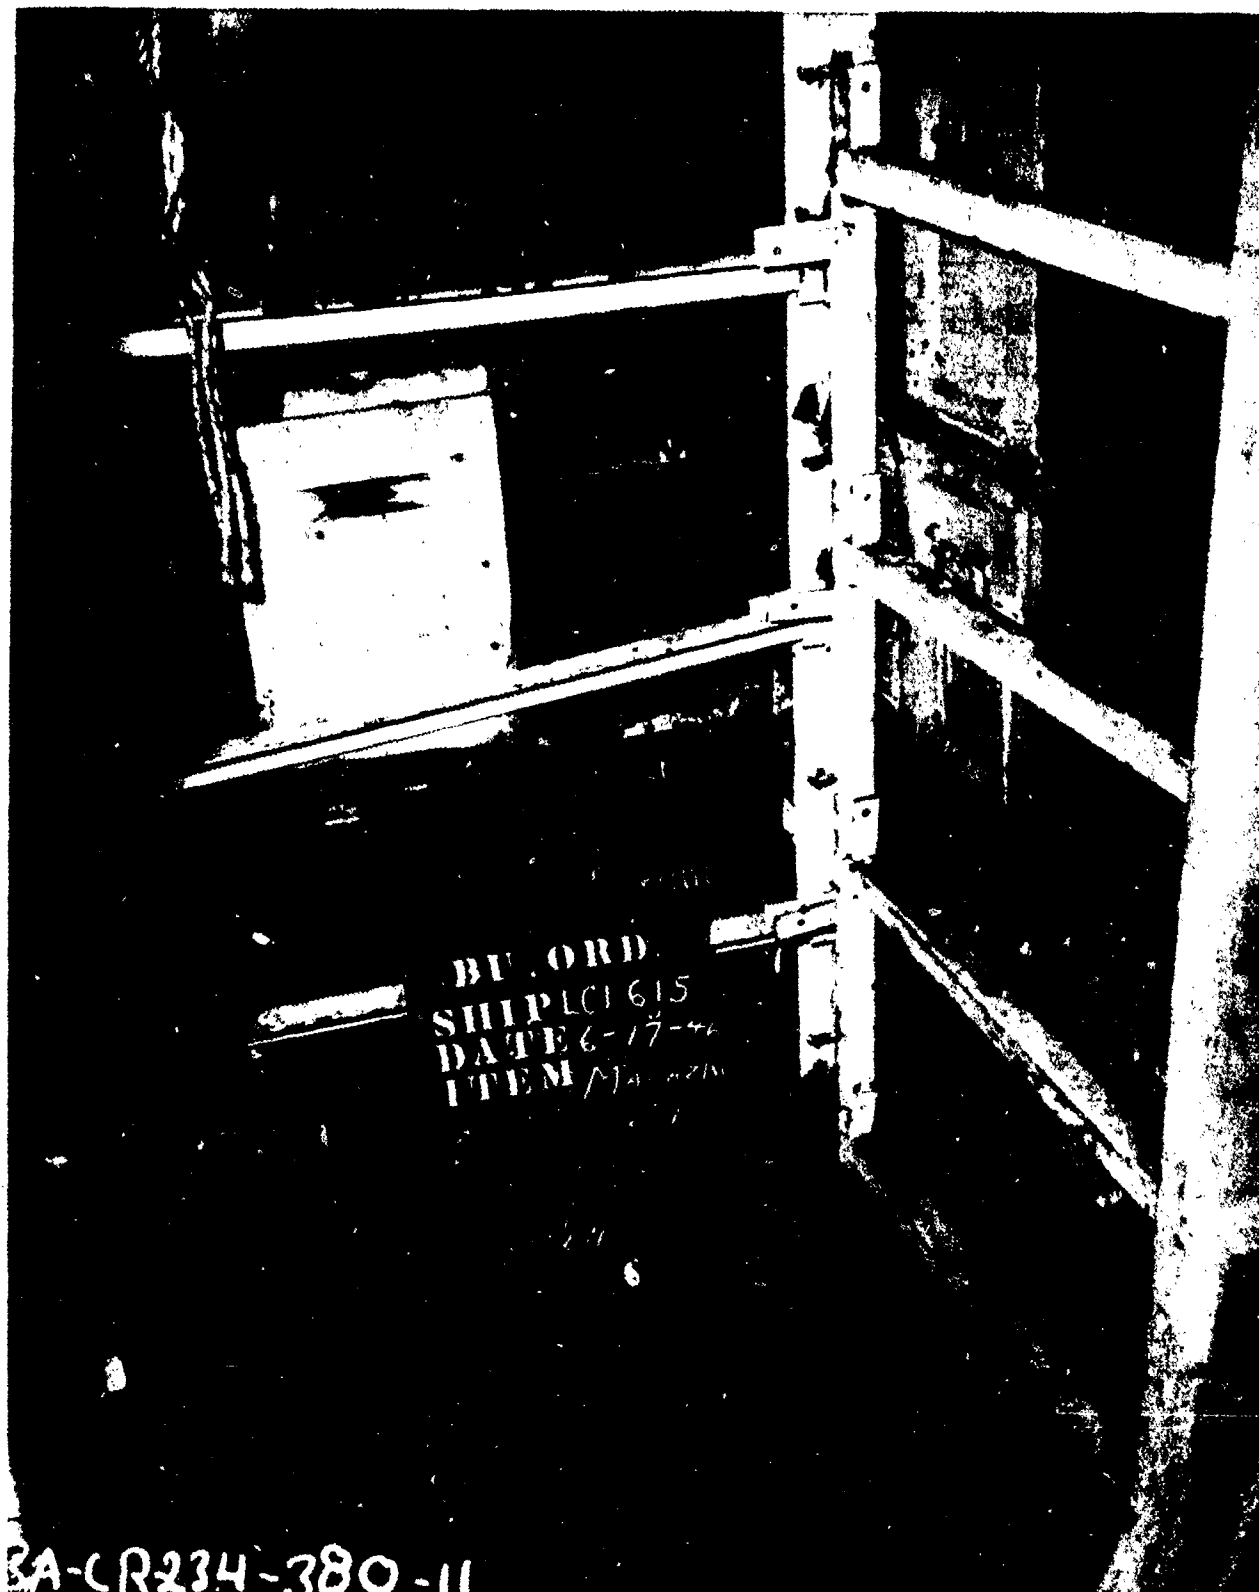
U.S.S. LCI-615 - Before Able  
Shows the Small Arms Storage in the LCI  
type magazine.  
Photo. No. BA-CR-234-380-11.

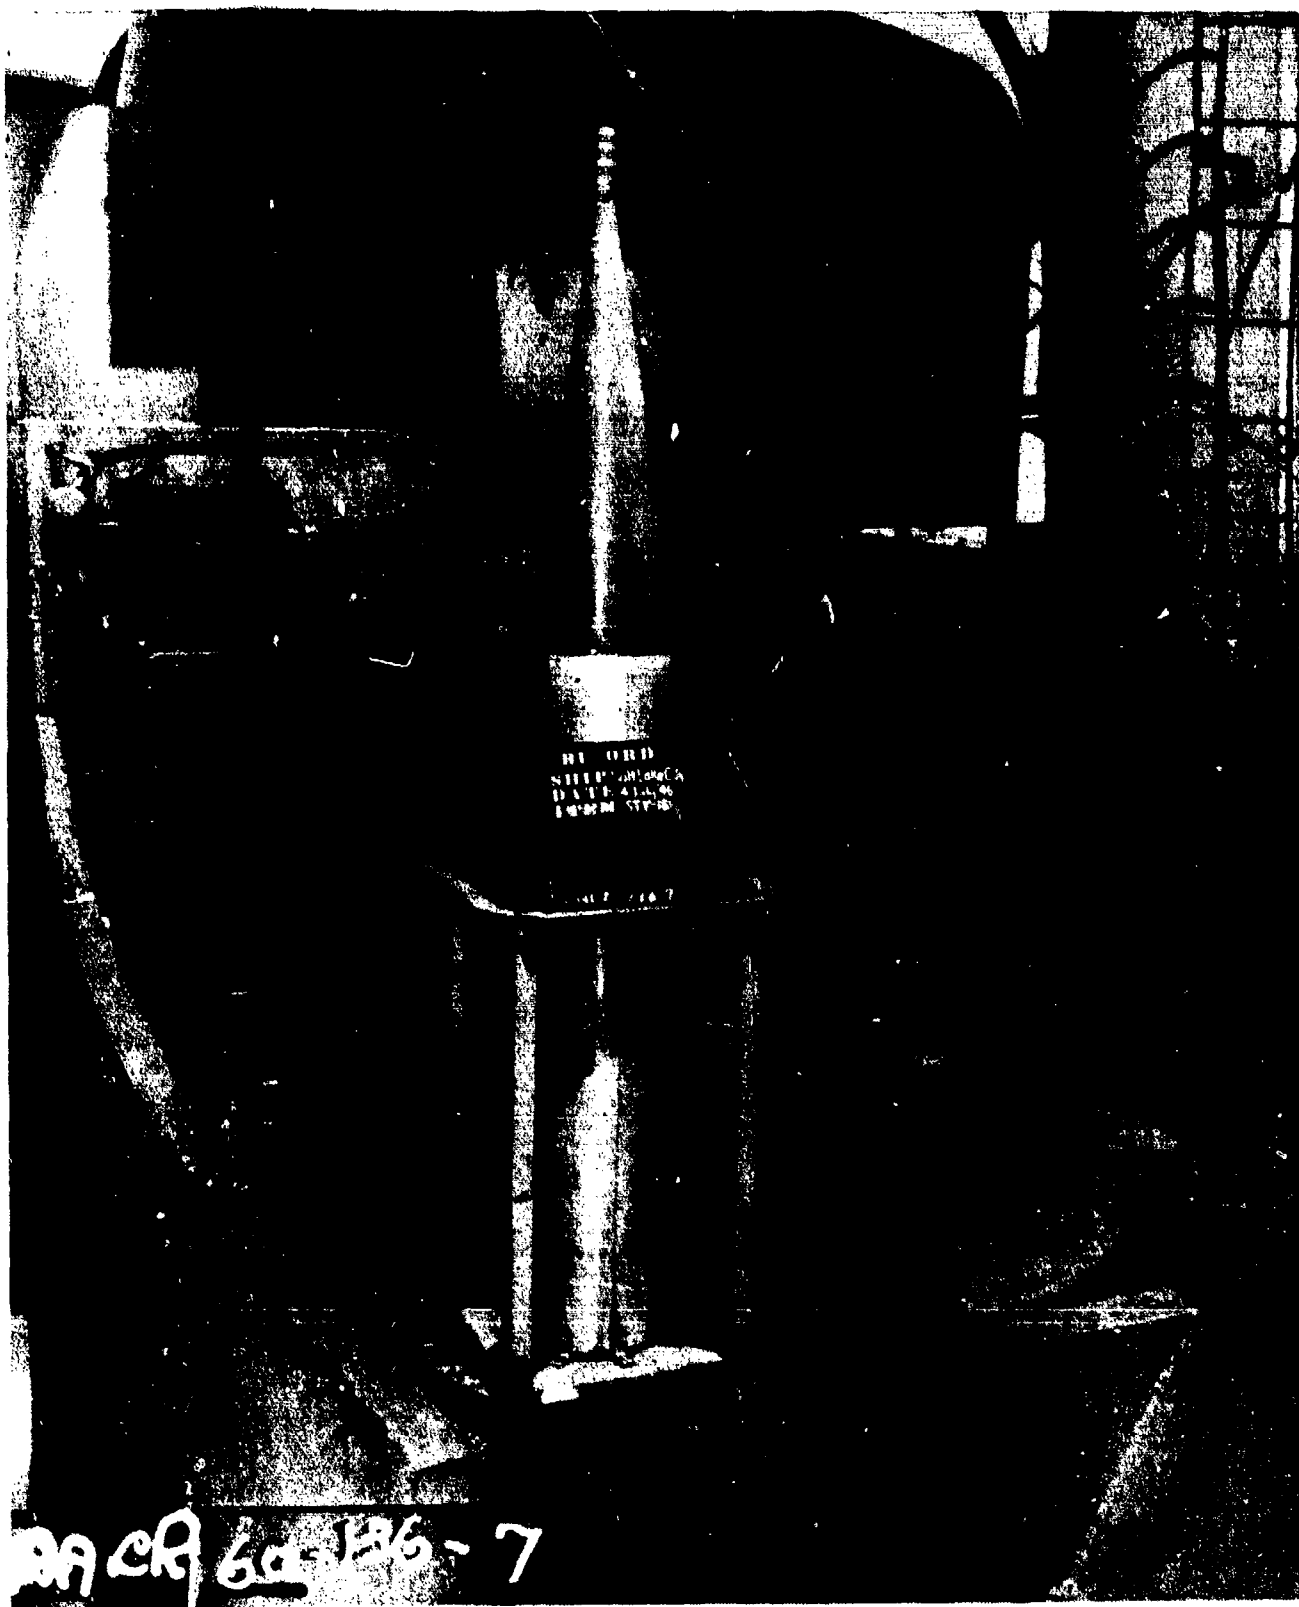
U.S.S. SALT LAKE CITY (CA-25) - after Able  
Shows the Special Guided Missile located on the main deck.  
No damage was inflicted from the "A" bomb.  
Photo. No. AA-CR-60-136-7.

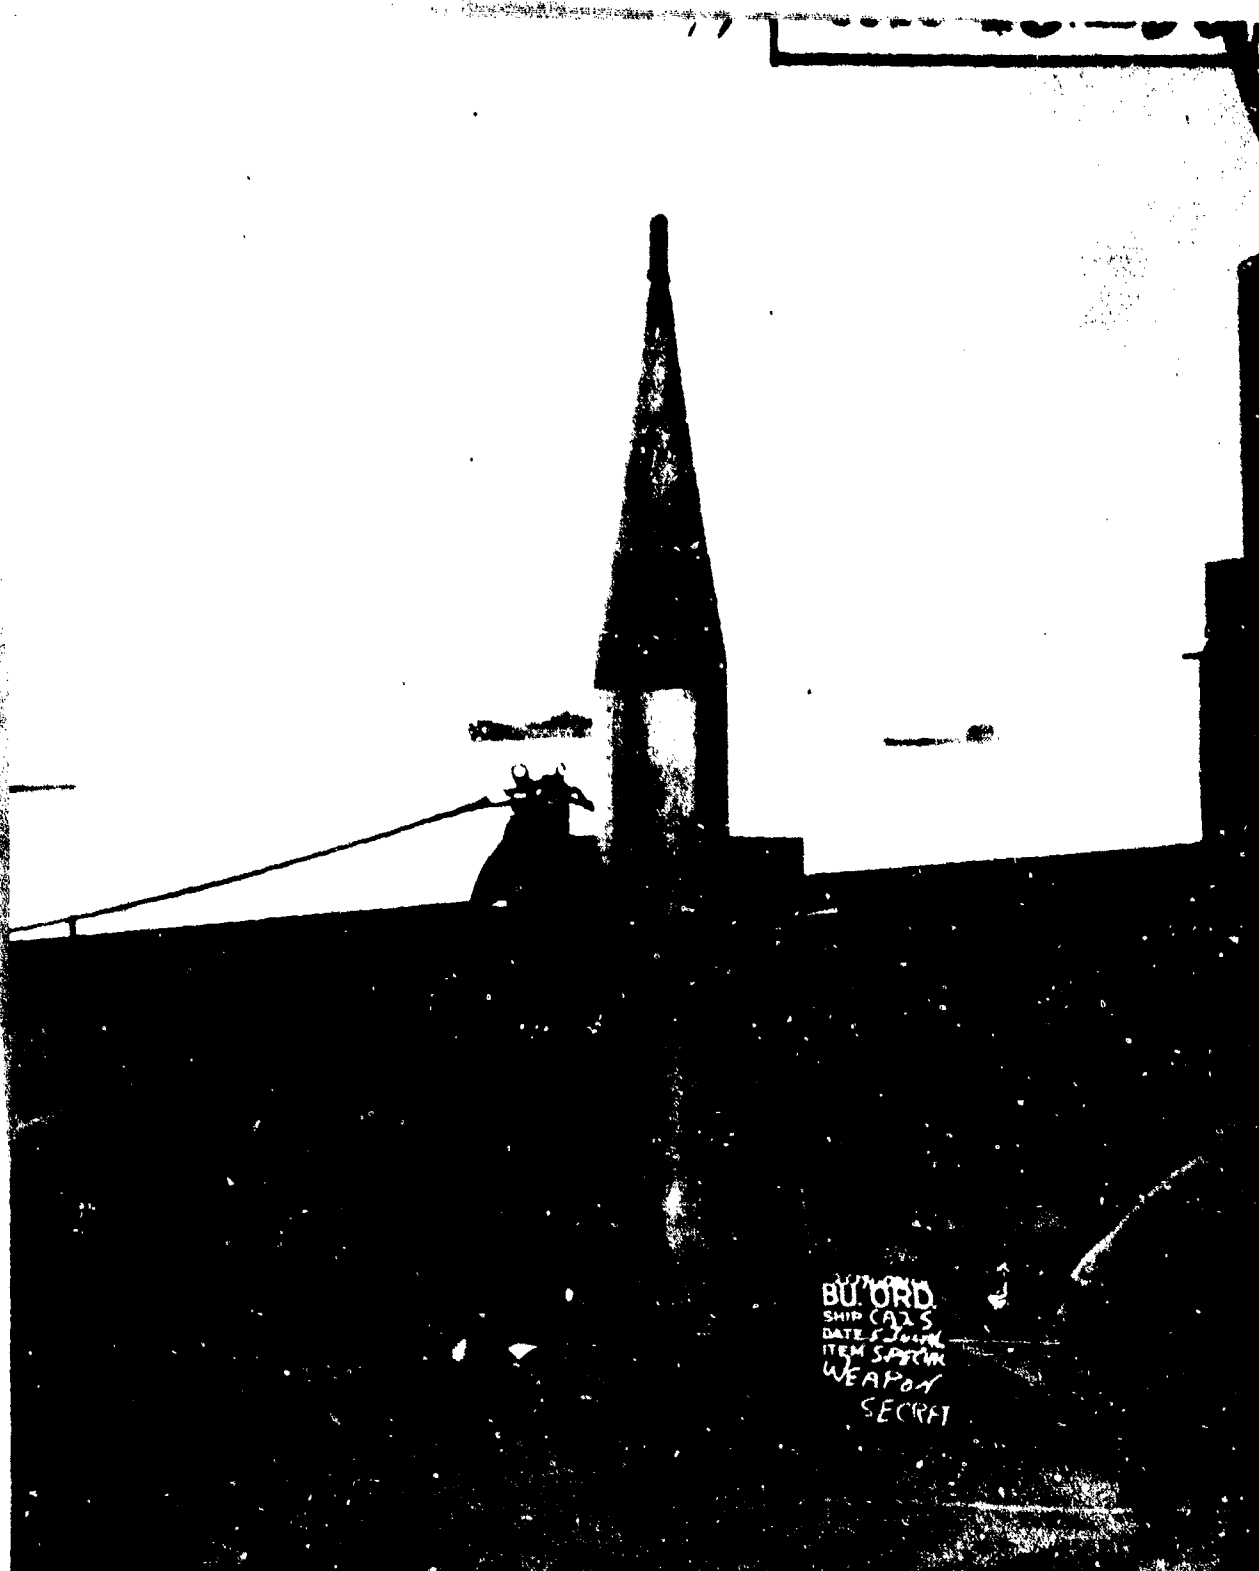
U.S.S. SALT LAKE CITY (CA-25) - After Able  
Shows the Special Guided Missile, (STV), after Test "A"  
and that it had remained unharmed. Pre-Test "A" picture,  
RA-CR-92-901-11 may be employed for comparison.  
Photo. No. AA-CR-87-2539-11.

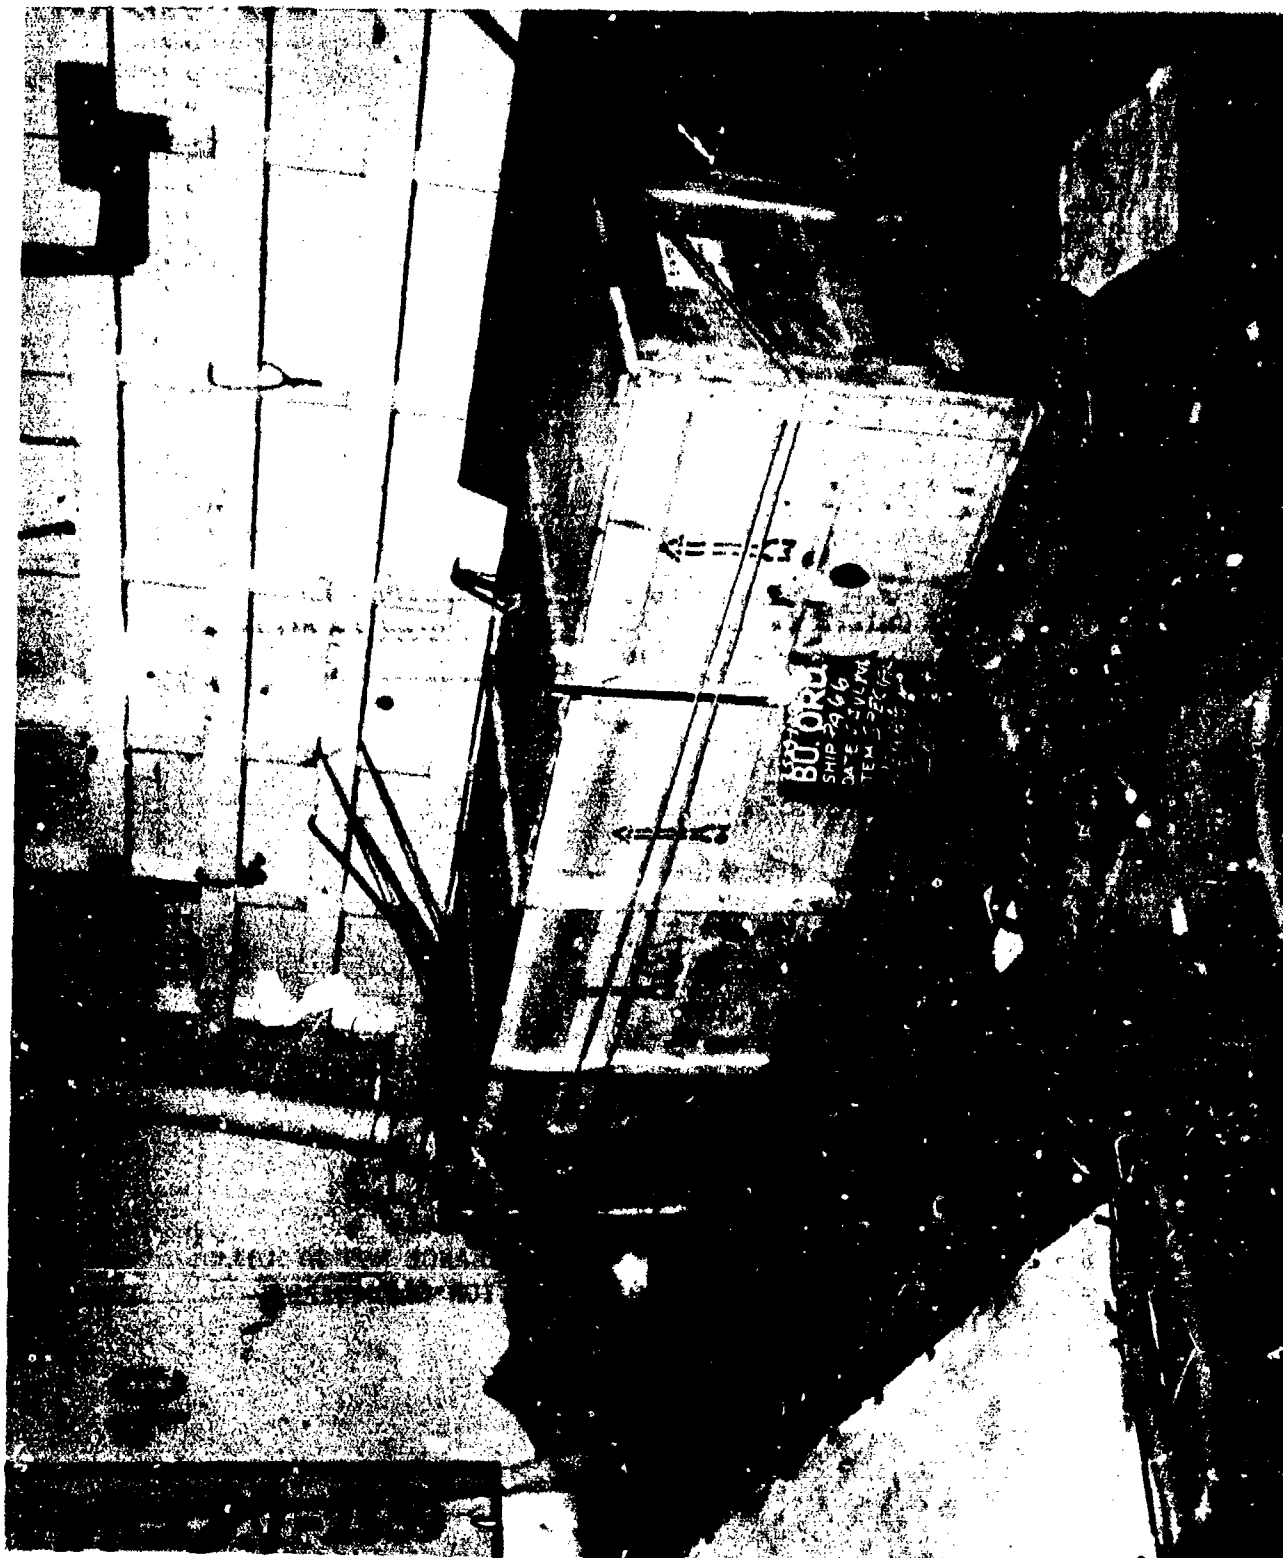
U.S.S. BRUIE (AFA-66) - After Able  
Shows the crated Special Guided Missile, (STV) after  
Test "A". The Missile remained unhurt.  
Photo. No. AA-CR-87-2539-10.
